# Eagle Home Inspections, LLC

## Confidential Inspection Report

1235 Your New St, Your Town, PA 1500  
Inspection prepared for: Joe Sample  
Real Estate Agent: Tammy Ulm - Keller Williams

Date of Inspection: 4/7/2014 Time: 3:30 PM  
Age of Home: 1977  
Weather: Rain, 56 Degrees  
Order ID: 54

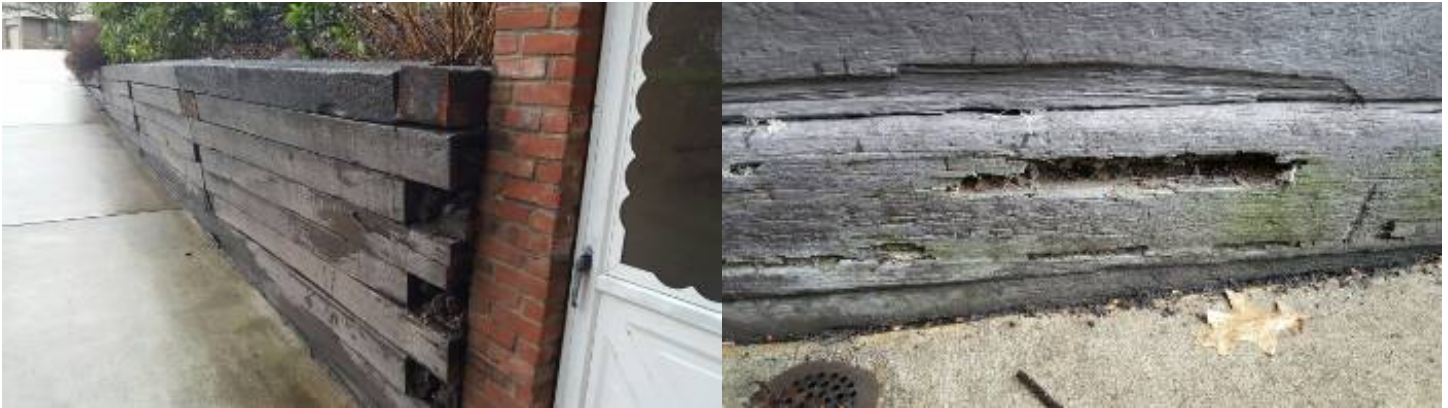
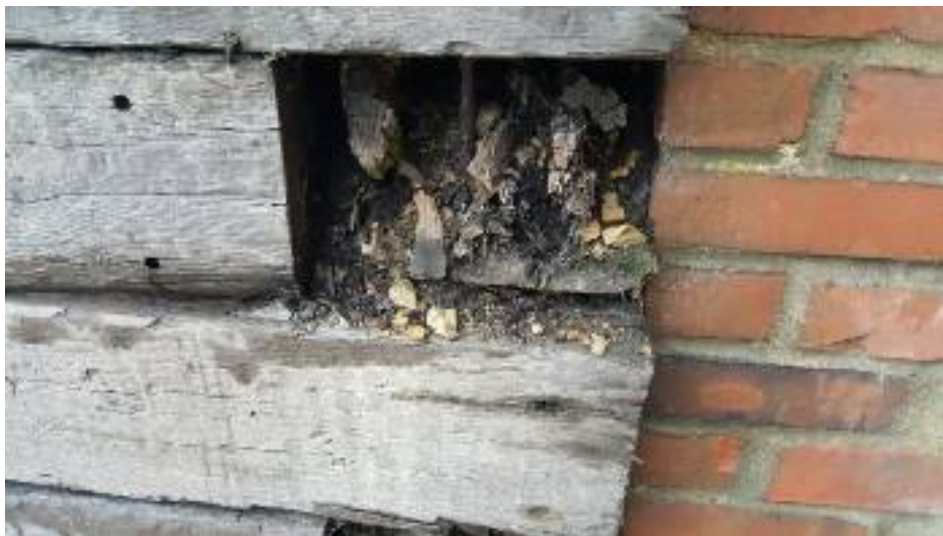
- The yard walls have areas of significant movement and damage which should be repaired or replaced by a contractor.

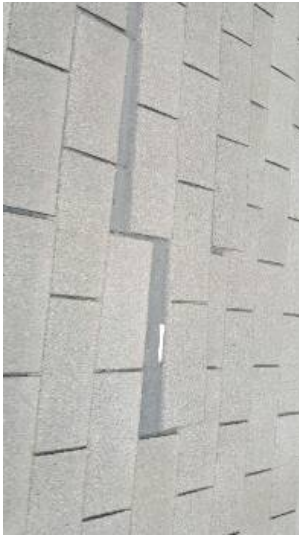
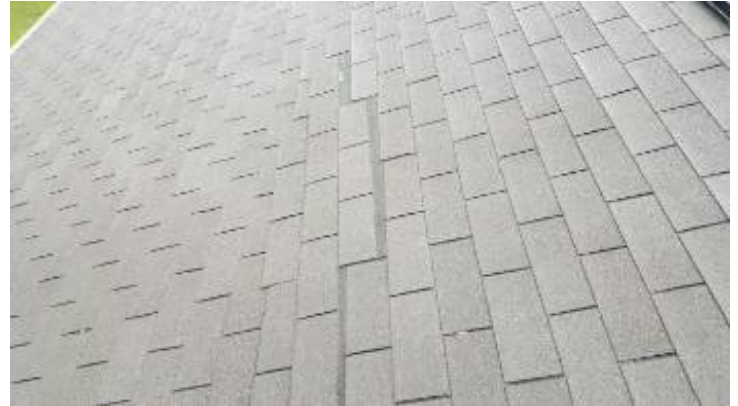
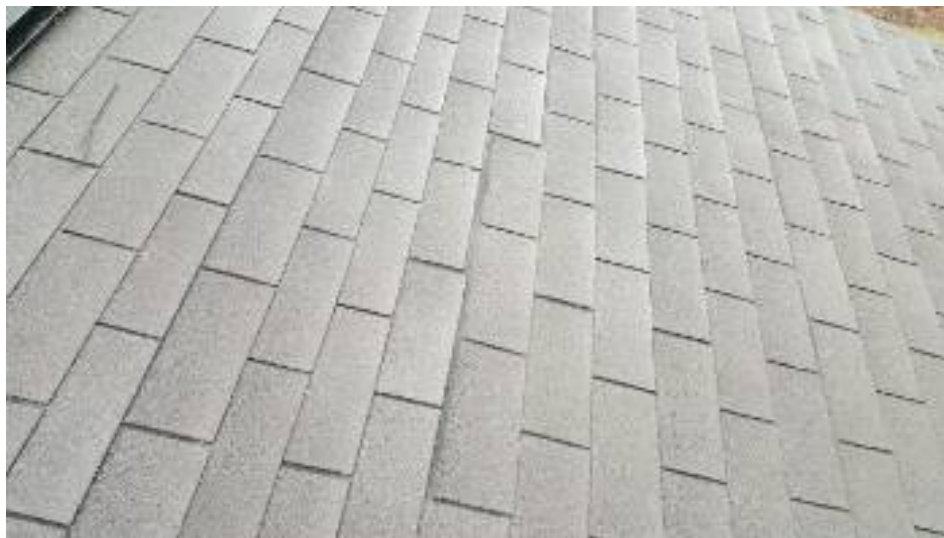
- The main composition shingle roof appears to be around 20 years old and the lower roof is around 25 years old. This is just an estimate and you should request the installation permit from the sellers, which will reveal its exact age and any warranty or guarantee that might be applicable.
- **The main composition shingle roof has areas of misplaced shingle tabs which should be repaired or replaced by a contractor. This service should be scheduled well before the close of escrow, because additional defects could be revealed by a specialist, and our service does not include any guarantee against leaks. For a guarantee, a roofing company would have to perform a water-test and issue a roof certification.**

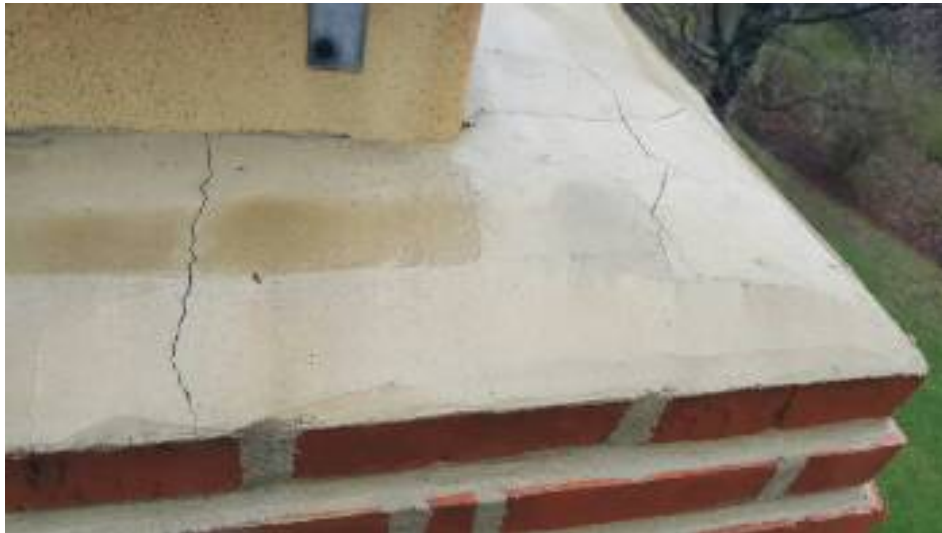
Page 11 Item: 3	Chimney Crown	<ul style="list-style-type: none"> <li>The chimney crown, which is designed to seal the chimney wall and shed rainwater, is cracked and should be repaired to help prevent moisture penetration. A qualified contractor or chimney sweep should further evaluate and make repairs as needed.</li> </ul>
Family Room Fireplace		
Page 12 Item: 2	Fireplace	<ul style="list-style-type: none"> <li>Fireplace is very dirty and needs cleaned and evaluated by a chimney sweep prior to use. Chimney flues need to be periodically cleaned to prevent the possibility of a chimney fire. However, the complex variety of deposits that form within chimneys are not easily understood. They range from pure carbon, which does not burn, to tars that can ignite. All of these deposits are commonly described as creosote, but creosote has many forms, ranging from crusty carbon deposits that can be easily brushed away, to a tar-glazed creosote that requires chemical cleaning. These deposits should be identified and treated by a specialist. However, cleaning a chimney is not a guarantee against a fire. Studies have proven that a significant percentage of chimney fires have resulted within one month of the chimney being cleaned, and many more have resulted within a six-month period.</li> <li>Fireplace has voids around damper housing which should be further evaluated by a chimney sweep and repaired as needed.</li> </ul>

- The chimney crown, which is designed to seal the chimney wall and shed rainwater, is cracked and should be repaired to help prevent moisture penetration. A qualified contractor or chimney sweep should further evaluate and make repairs as needed.

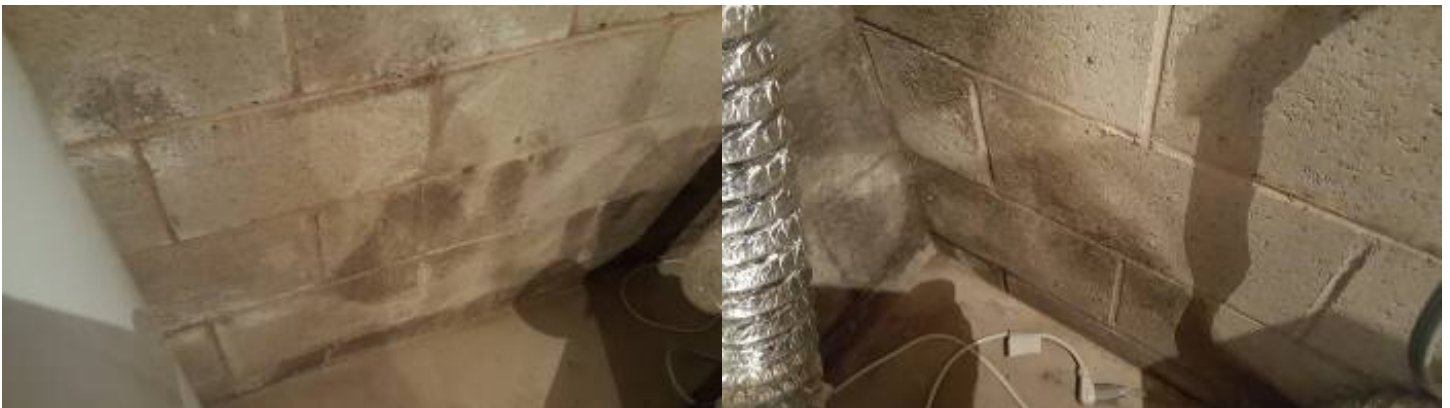
Page 24 Item: 3	Moisture or Dampness	<ul style="list-style-type: none"> <li>• There is efflorescence or staining on the basement or lower level walls, which is caused by moisture intrusion and which is not uncommon. Nevertheless, you should ask the sellers if this area has ever flooded, then be prepared to monitor it, and you should not store any materials either directly on the floor or against the walls. The exterior grading around the house should be built up to slope away from the house at a drop of 5 inches over 5 feet (one inch per foot). As with most basements, you should know that future moisture penetration is possible, and you should consult a specialist to further evaluate.</li> </ul>
Water Heater		
Page 28 Item: 6	Vent Pipe And Cap	<ul style="list-style-type: none"> <li>• The water heater was backdrafting at the time of the inspection. This may allow carbon monoxide to enter the living space and should be further evaluated by a plumber and repaired as needed. The chimney flue used to have the furnace and water heater both venting in to it. A high efficiency furnace has been installed and now only the water heater vents in to this chimney. Depending on the temperature outside, this water heater may not always vent properly. A separate liner may be needed that connects at the water heater and runs continuously through the existing chimney to the exterior at the top of chimney. This should be done whenever a furnace is removed from the chimney flue, leaving the water heater as the only item venting into it.</li> </ul>

- There is efflorescence or staining on the basement or lower level walls, which is caused by moisture intrusion and which is not uncommon. Nevertheless, you should ask the sellers if this area has ever flooded, then be prepared to monitor it, and you should not store any materials either directly on the floor or against the walls. The exterior grading around the house should be built up to slope away from the house at a drop of 5 inches over 5 feet (one inch per foot). As with most basements, you should know that future moisture penetration is possible, and you should consult a specialist to further evaluate.
